709 , 909
3/4"-2"

WATTS[®]

Modification Overview

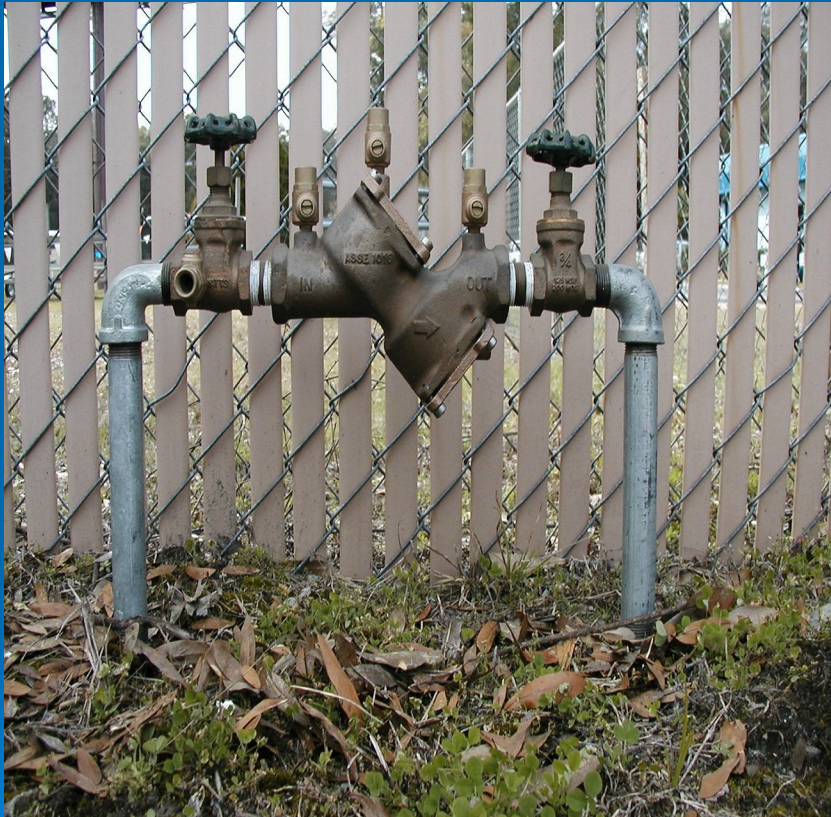
- The 909M1 (1989) in the $\frac{3}{4}$ -2" sizes only.
- Change was in the body only- internal components are the same.
- The 709 in $\frac{3}{4}$ -2" sizes only, was discontinued in 1993.

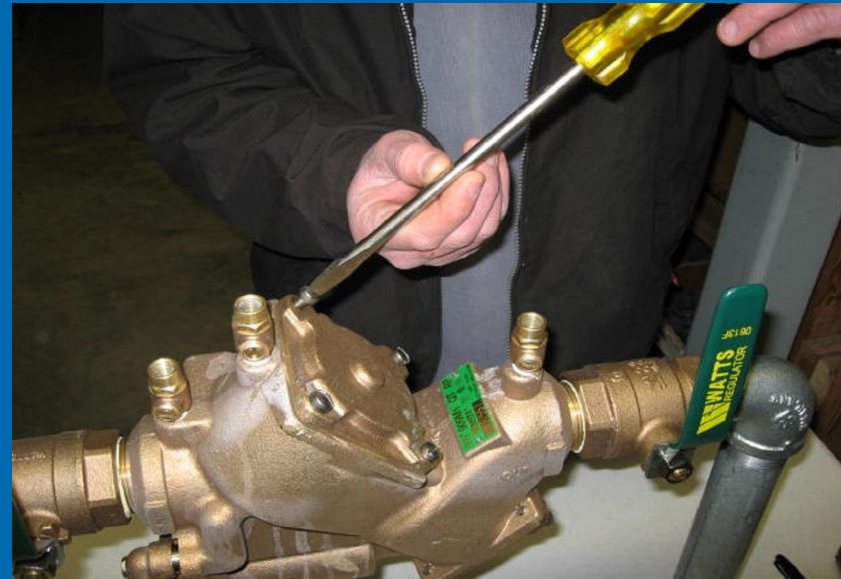
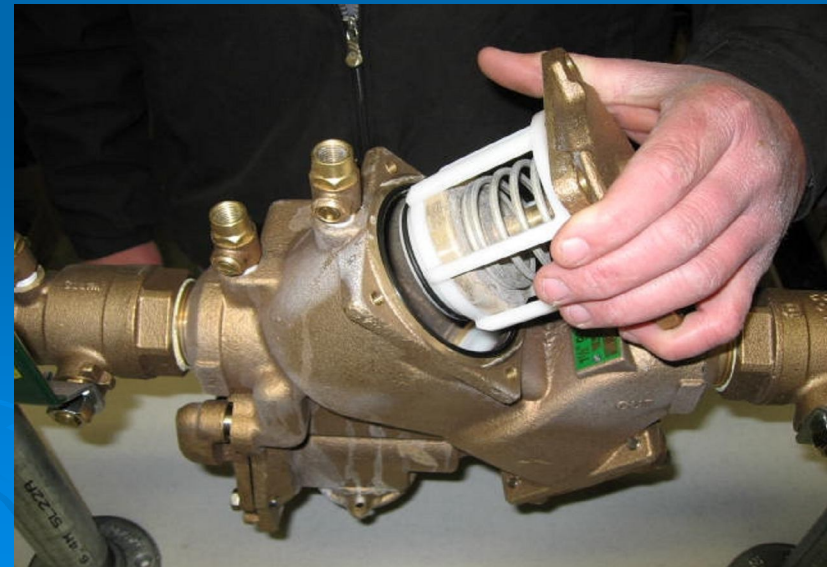
Check Cover Removal

- Cover is o-ring sealed.
- Check valve assembly is attached to the cover and spring is contained.
- Pull cover and assembly straight out of the body. (Do not twist)

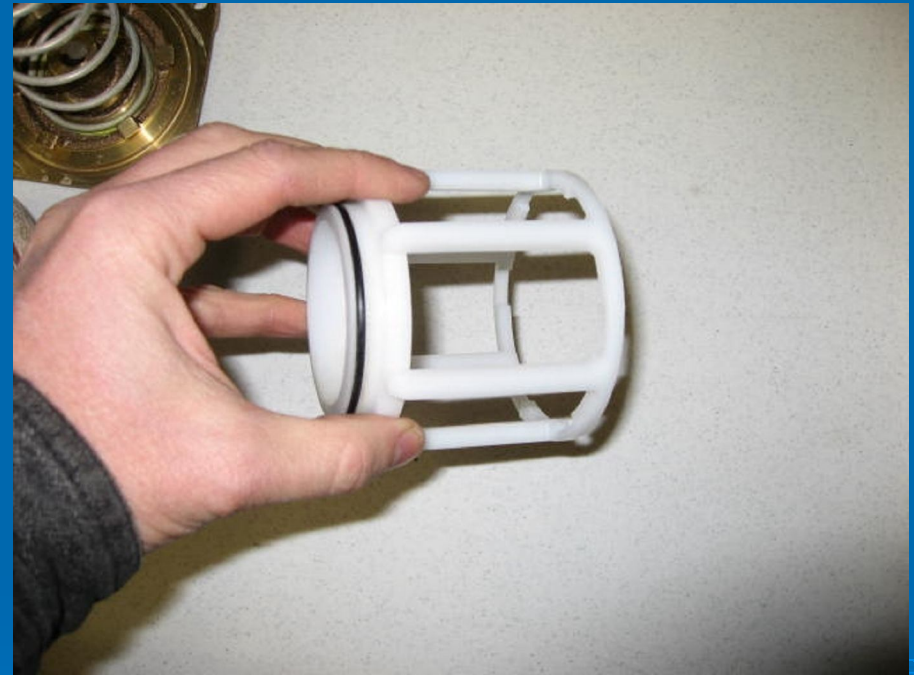
Check Seat Removal

- Once the cover and check valve are removed the seat or (cage) is free.
- Seat is sealed by an o-ring.

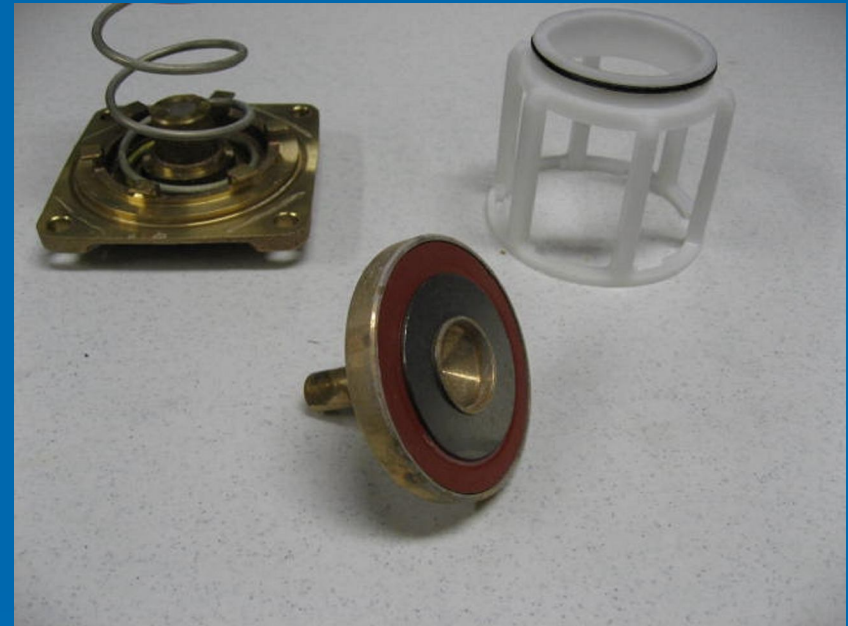
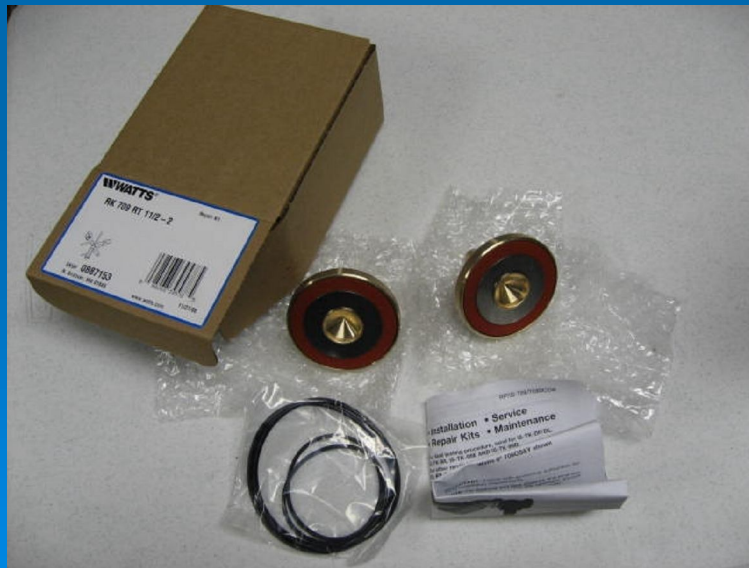
Check Disc Replacement

- Check disc and disc holder can be replaced as one piece.

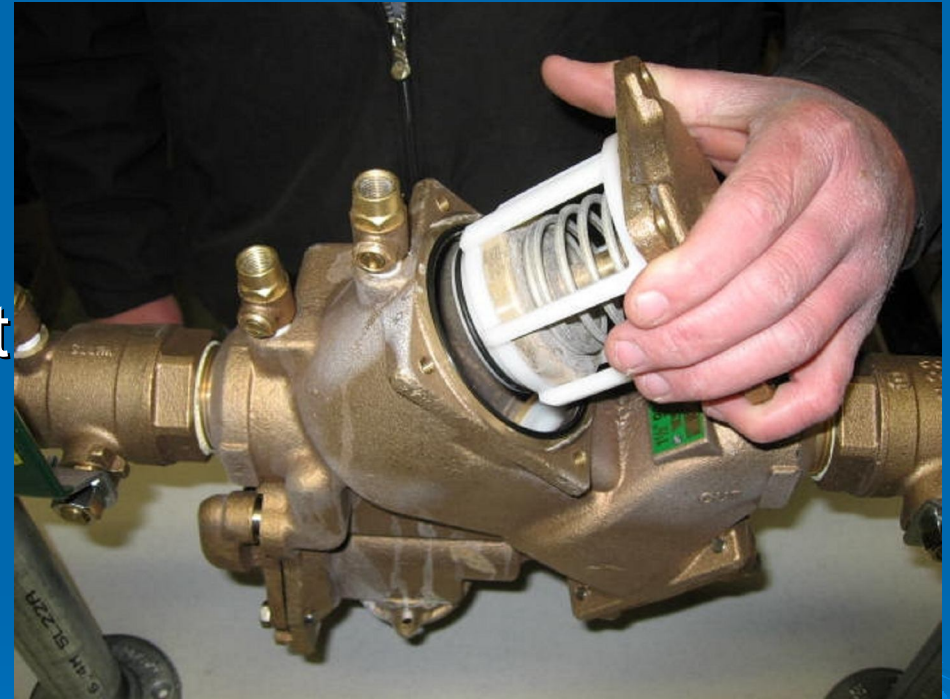
Check Valve Reassembly Notes

- Reassemble check valve in reverse order.
- Apply lubricant to seat o-ring and lid o-ring.

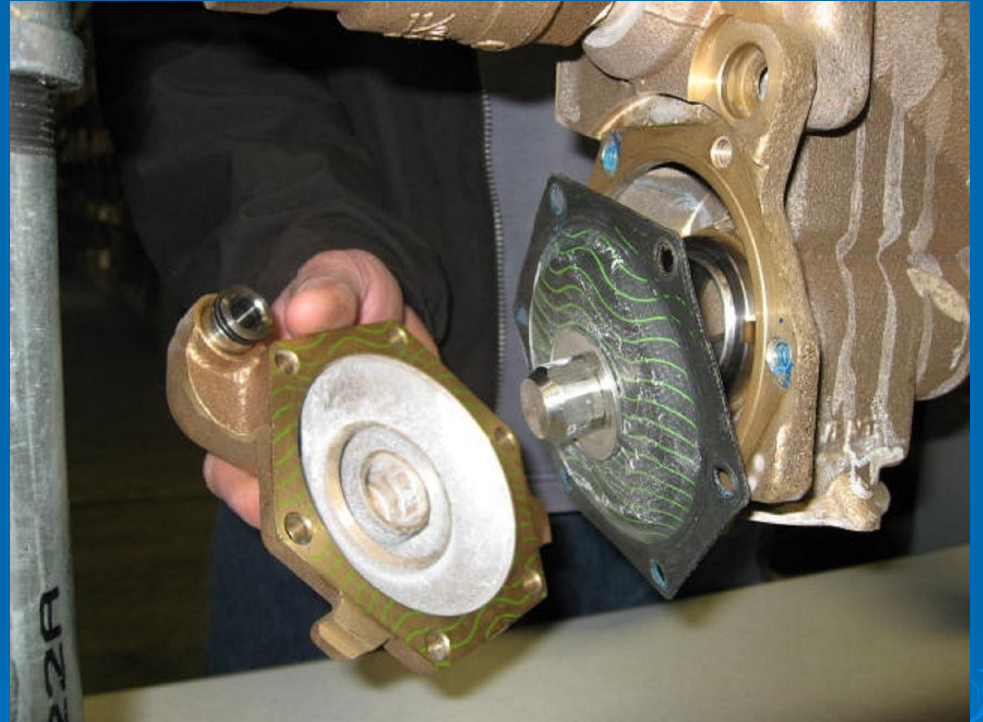
RV Cover Removal

- RV Cover is sealed by the diaphragm.
- Spring load is contained.

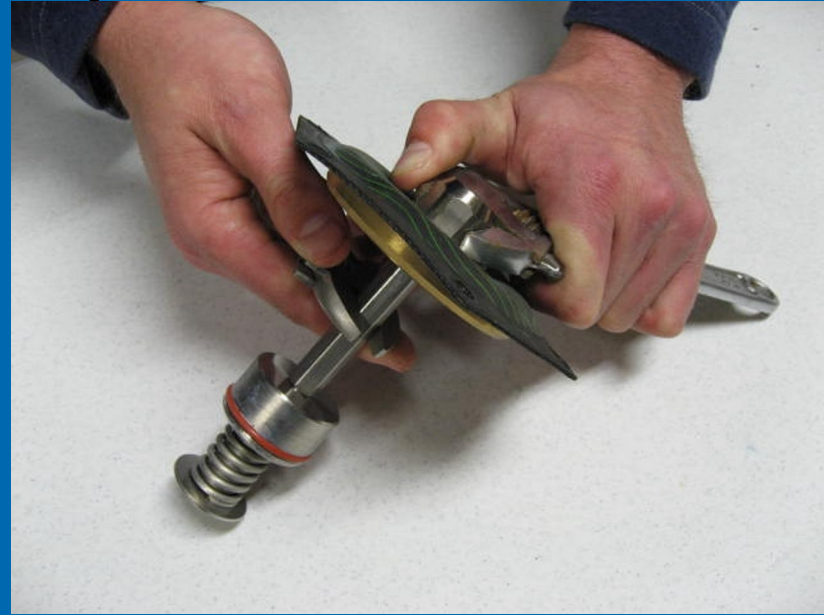
RV Rubber Replacement

- Replace diaphragm and RV disc assembly.
 - * Simply unscrew the stem cap from the stem.
- Replace stem o-rings.
- Apply lubricant to o-rings.

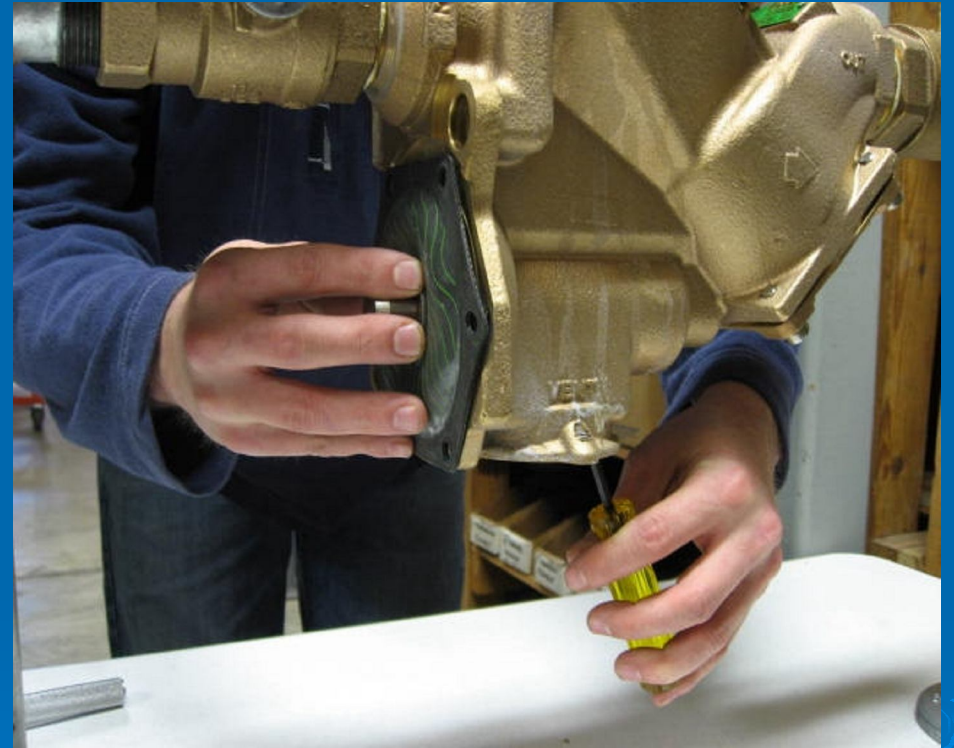
RV Reassembly Notes

- Insert RV stem assembly into body.
 - * Carefully guide and depress spring tension until the piston is completely into position.
 - * Insert screw driver up into vent opening to hold stem in place.
- Bolt cover down evenly.
