# 800 (M2,M3,M4) 1⁄2"-2"

#### Modification Overview

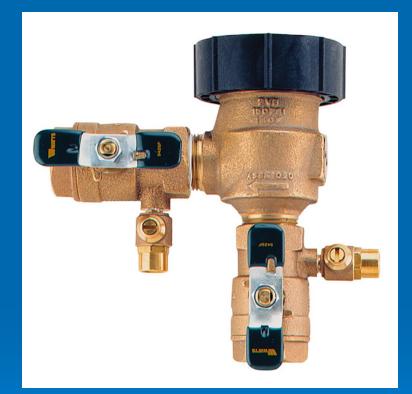
- The original model 800 was discontinued in 1993.
- The 800M2 was produced from 1991-1994.
- The 800M3 (1/2",3/4" sizes only) was produced from 1991-1994.
- The 800M4 production began in 1994 and is the current model.

The 800M4FR was introduced in 1995 and is produced with a float assembly that contains a relief valve that protects the unit against freeze damage.

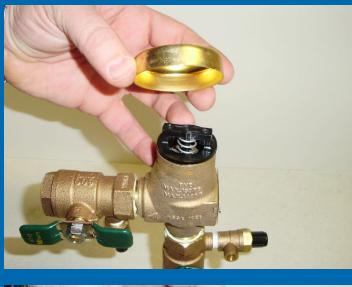
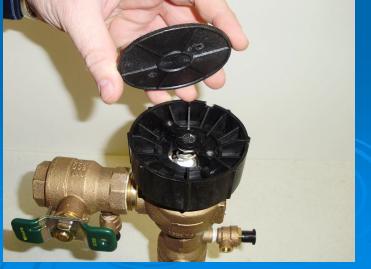
# Hood Removal

The ½"-3/4" hood is secured by two screws.

The 1"-2" hood is secured by two screws.

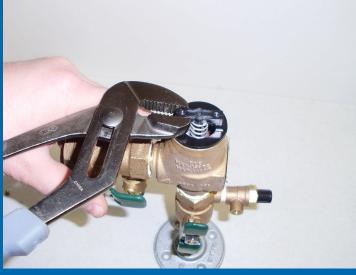
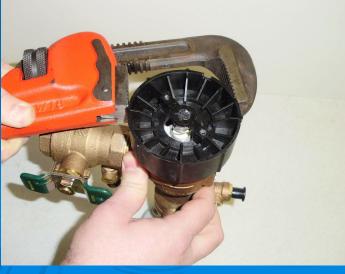
### **Bonnet Removal**

The bonnet is threaded into the body and sealed by an o-ring.
There is no spring

load.

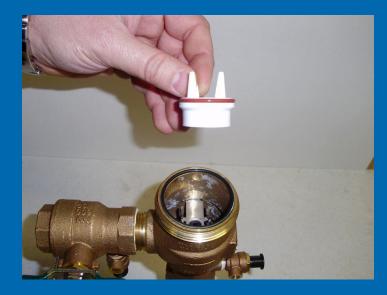
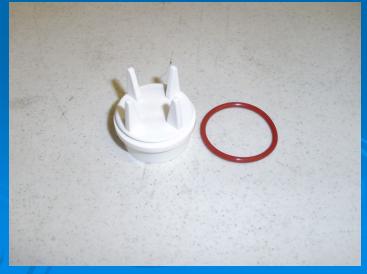
### Float Removal and Service

- The float is free once the bonnet has been removed.
- Replace the rubber seal by pulling it from the groove on the float.

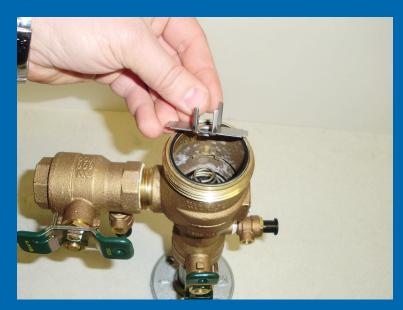
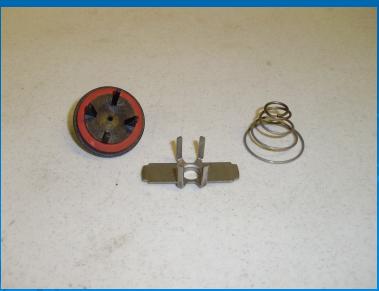
### **Check Valve Removal**

- Check valve is spring loaded.
- Remove spring retainer by pressing down and rotating to clear tabs on the body.
- Remove spring and poppet.

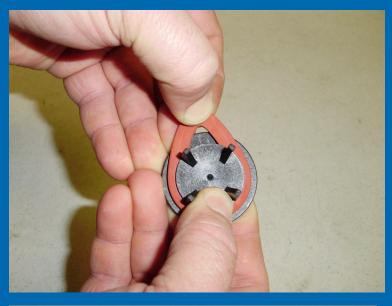
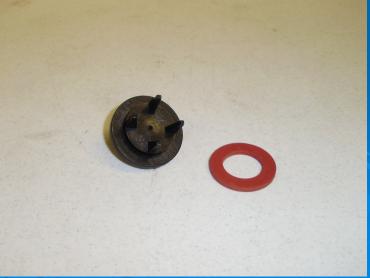
### **Check Disc Replacement**

Replace the rubber disc by pulling it from the groove on the poppet.

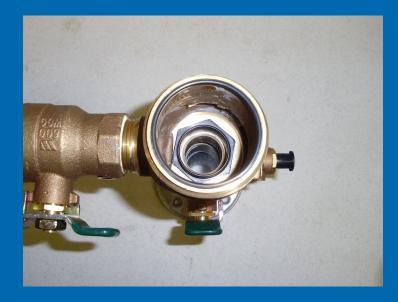
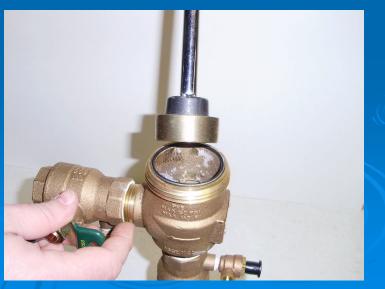
#### **Check Seat Replacement**

- Models 800,800M2 and 800M3 did not have replaceable check seats.
- The 800M4 check seat is threaded into the body and sealed by an o-ring.
- \*\* Note: A special tool is needed to remove the seat.

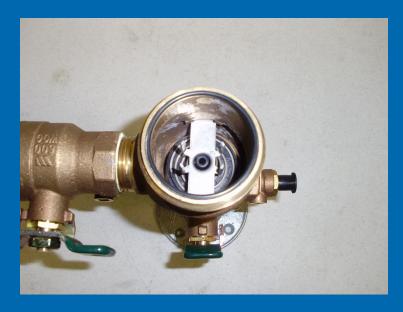
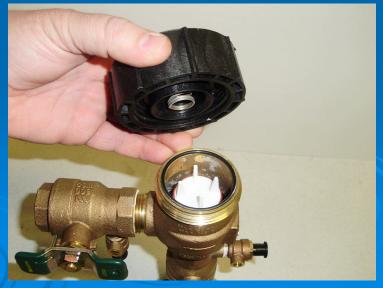
### **Reassembly Notes**

Reassemble in reverse order. Place large end of spring down in body. > The guides on the retainer face up. > The guides on the float face up. Make sure the float spring is centered on the float.
