950, 950DA 975, 975DA 2 1/2"-10"

Modification Overview

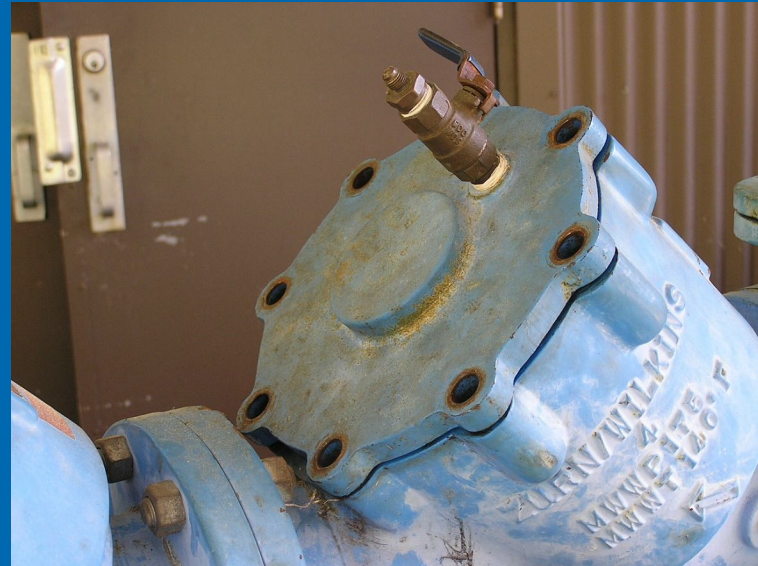
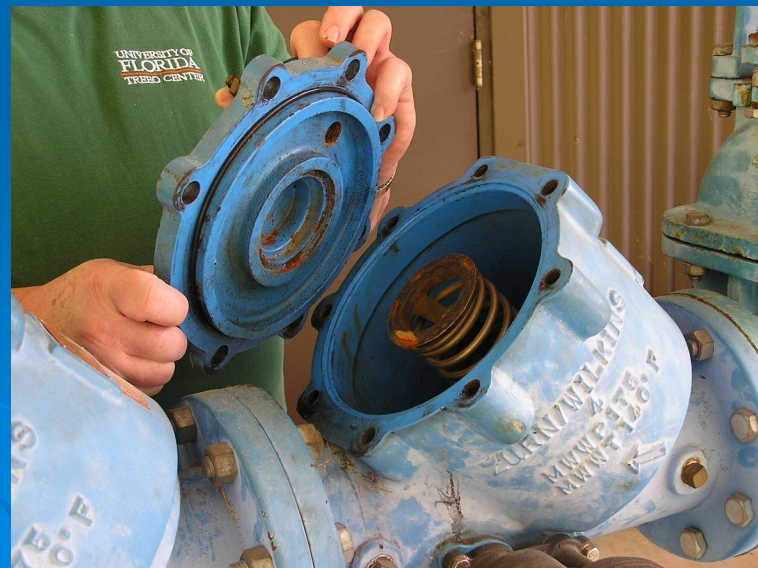
Check Cover Removal

- Cover is o-ring sealed.
- Loosen bolts 1/2". The spring load is now released from the cover and retained by the check subassembly.

** Verify spring load before removing all the bolts.

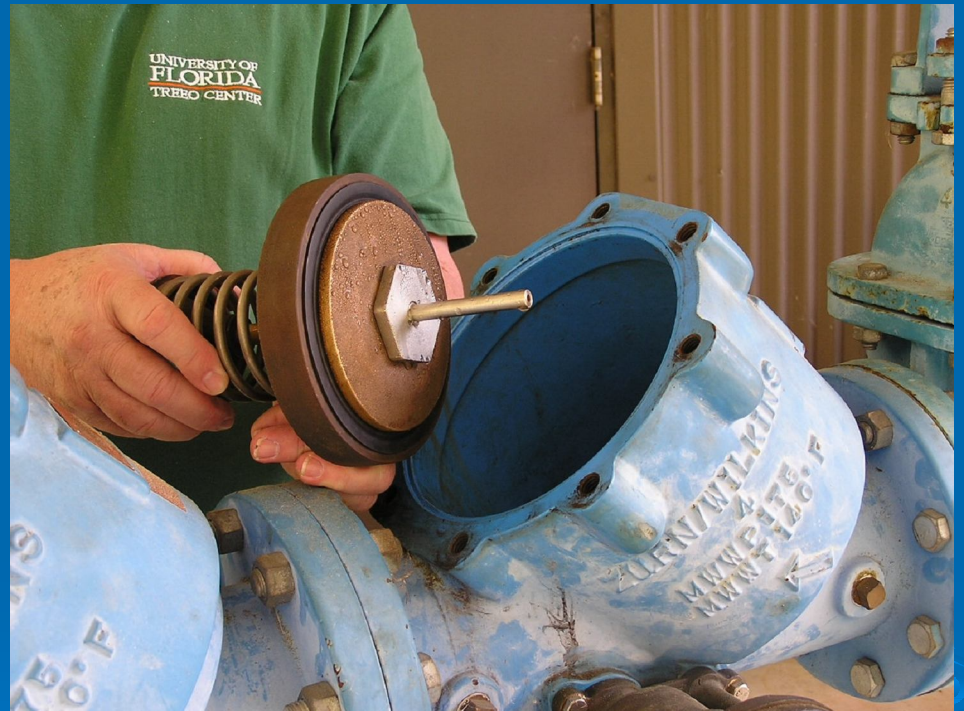
Check Valve Removal

- Center stem guided check assembly.
- Disc & spring subassembly.
- Slide subassembly straight out of seat and body.

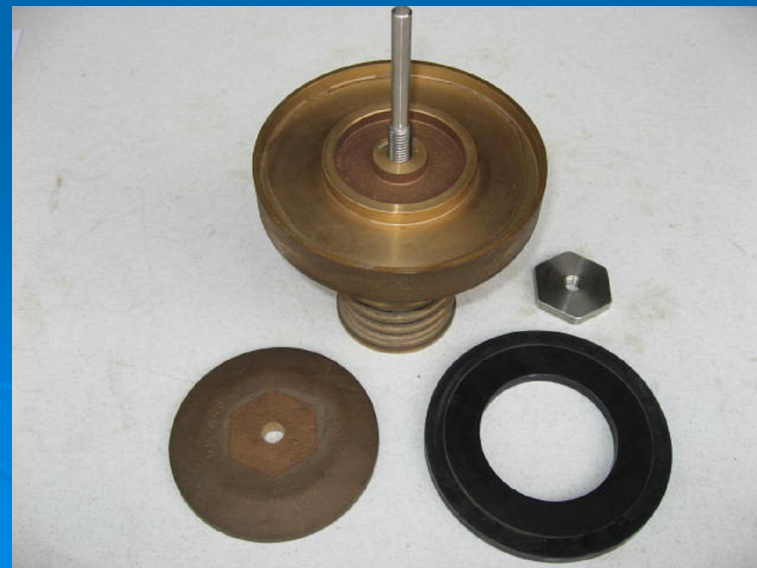
Check Disc Replacement

- Remove retaining nut and disc retainer.

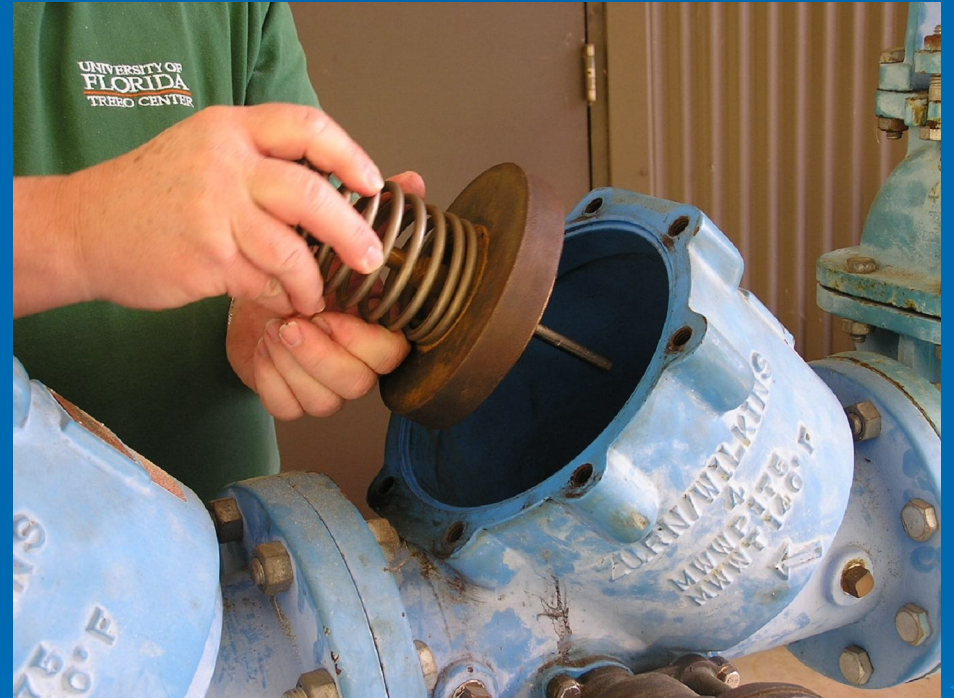
Check Valve Reassembly Notes

- Reassemble checks in reverse order.
- Lubricate o-rings.

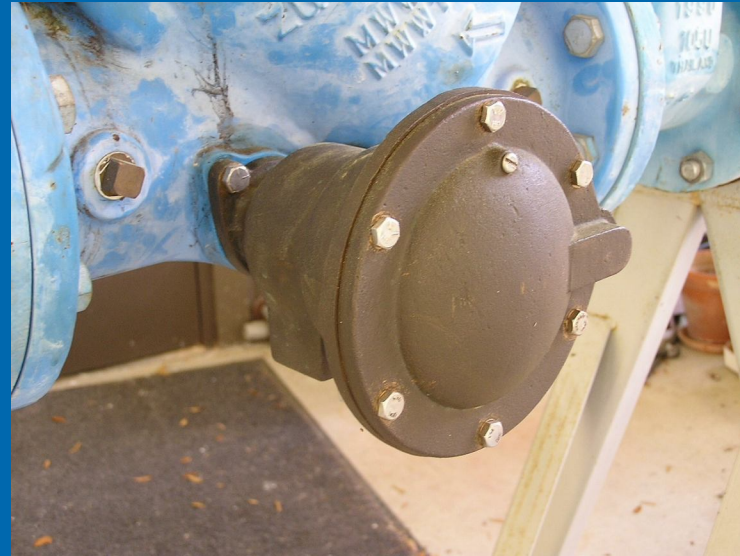
RV Cover Removal

- Cover is sealed by the diaphragm.
- There is no spring load on cover.
- Remove bolts.

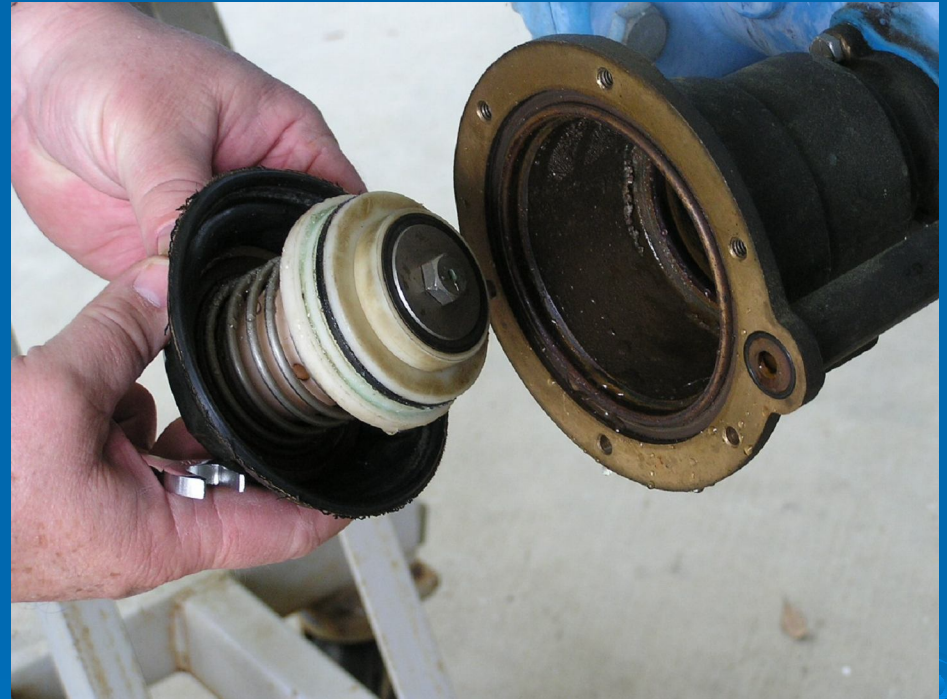
RV Module Removal

- Module is o-ring sealed.
- Pull the module straight out of body.

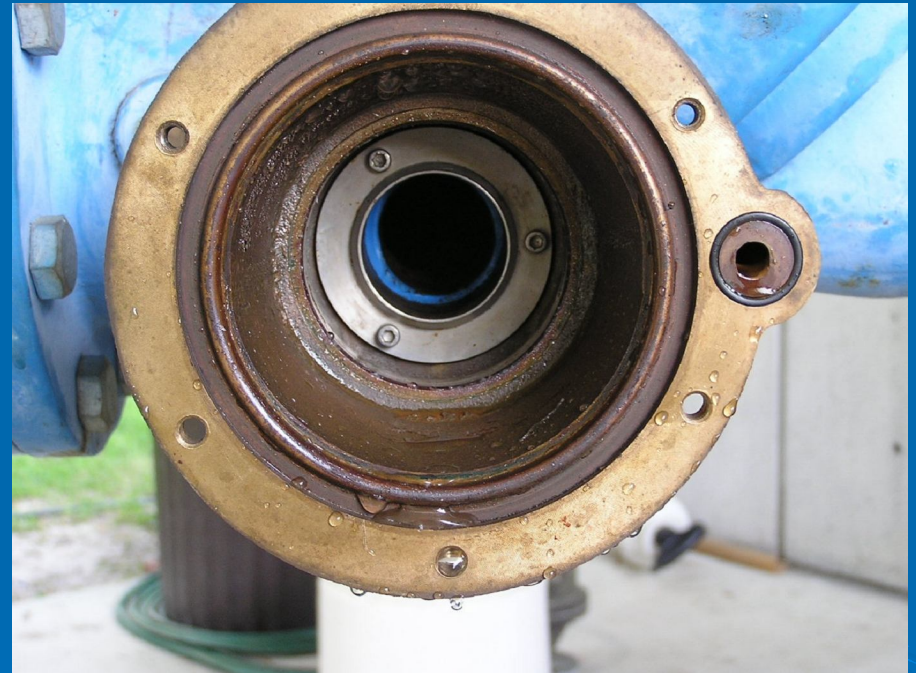
RV Seat Removal

- 2 1/2"-6" RV seat is bolted into body and o-ring sealed.
- Remove the allen screws and pull seat straight out of body.
- 8"-10" RV seat is threaded and o-ring sealed.

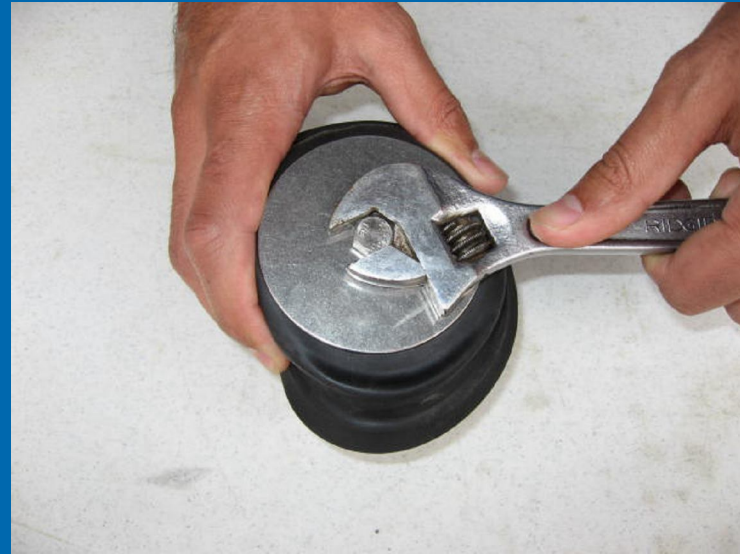
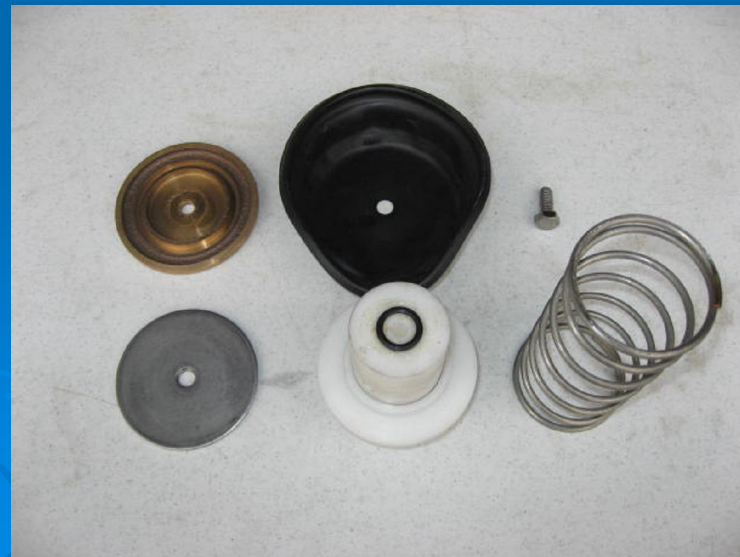
Disassemble RV Module

- Module is spring loaded.
- Holding the module firmly, remove the stem bolt.

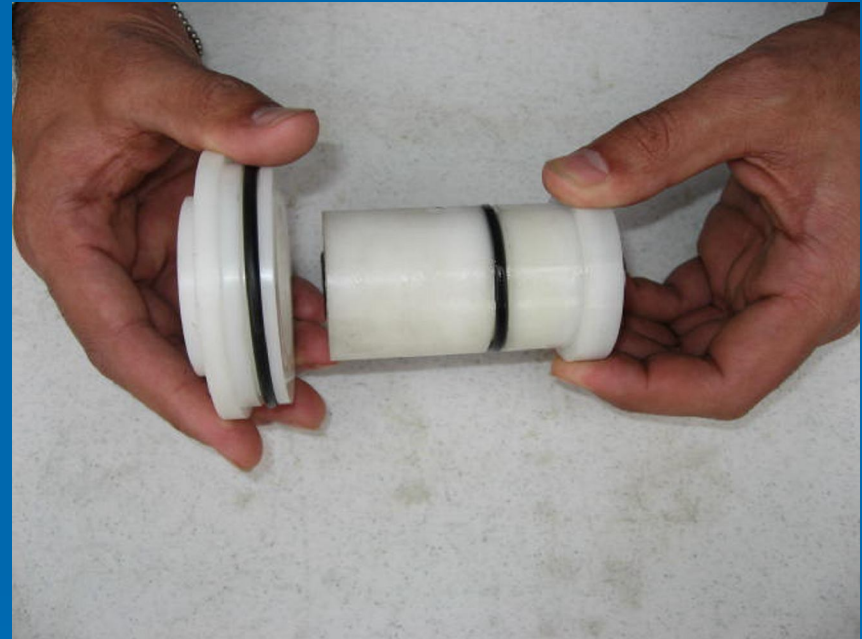
Disassemble RV Module

- Remove the guide bushing from the stem.

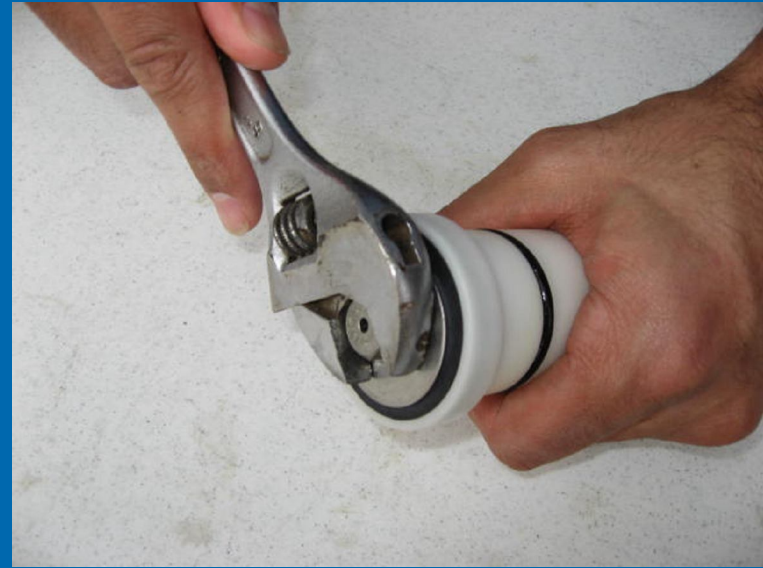
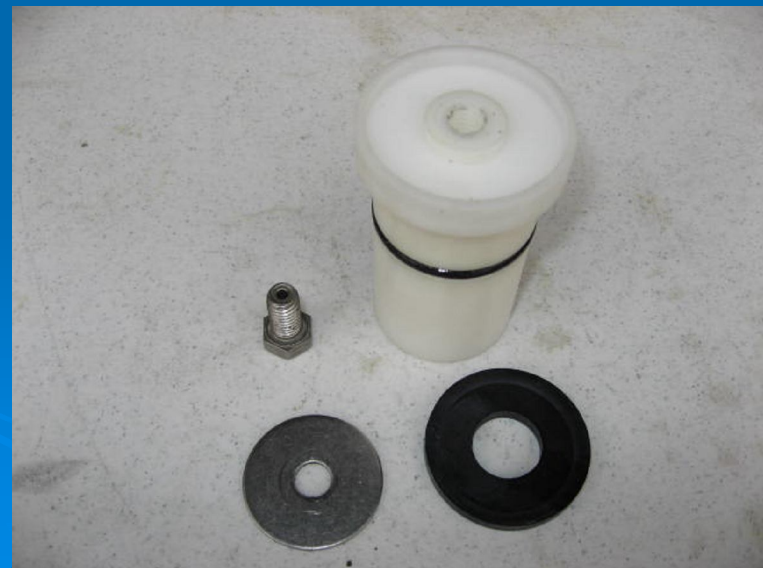
RV Disc Replacement

- Remove retaining bolt, disc washer, and disc.
- Reassemble in reverse order.

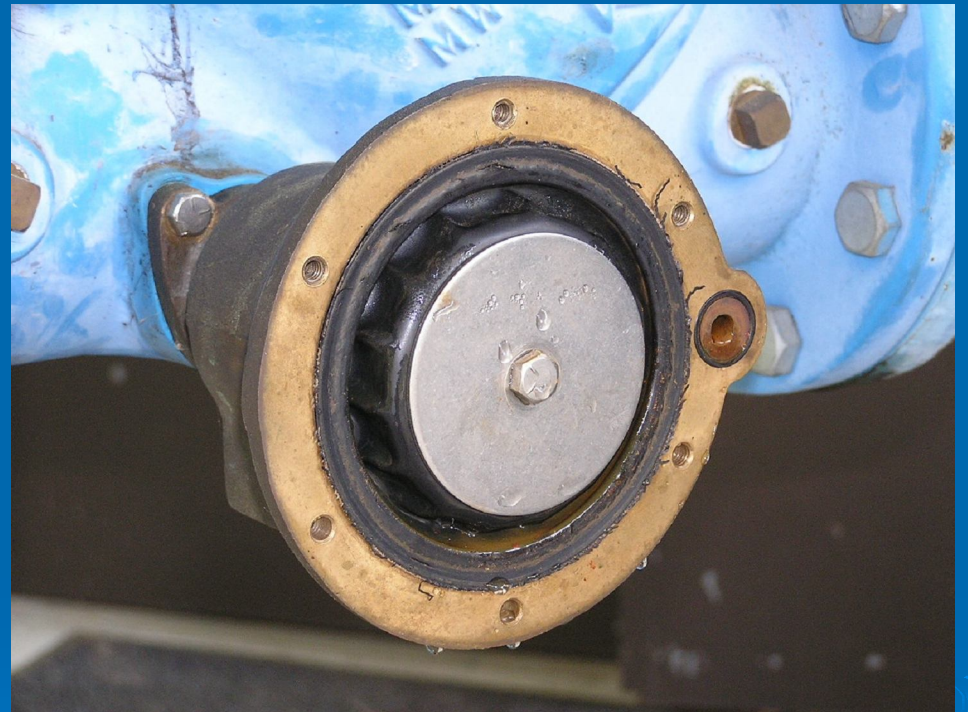
RV Reassembly Notes

- Bead on the edge of the diaphragm should face the disc end of the module.
- Lubricate o-rings.
- Push the module straight into the body.
- Diaphragm bead will line up with the groove on the RV body.
- Check the sensing line o-ring on the cover.
