40-500  
1/2" - 2"

# *Modification Overview*

- The ½"-2" 40-500 PVB was discontinued in 2003.

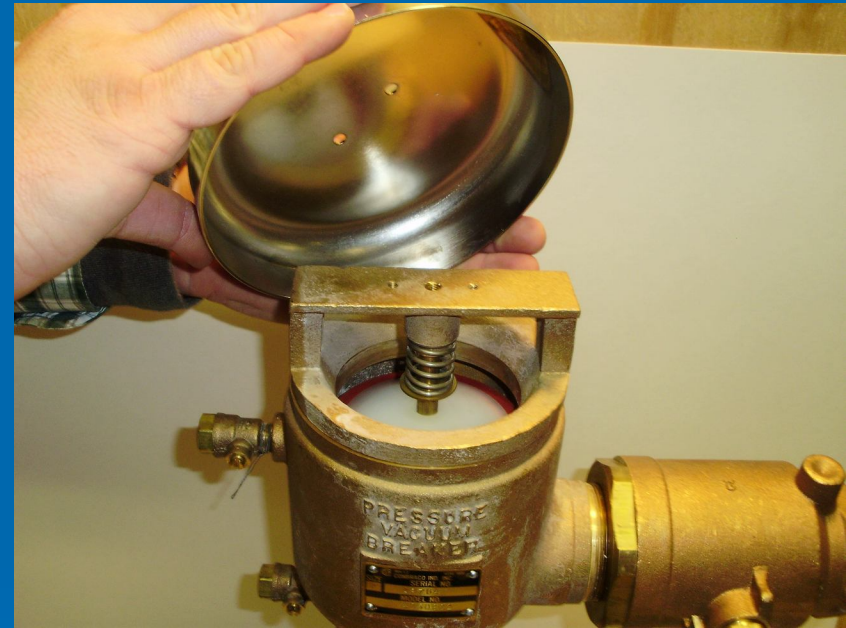
# Canopy Removal

- The canopy is secured by two screws.

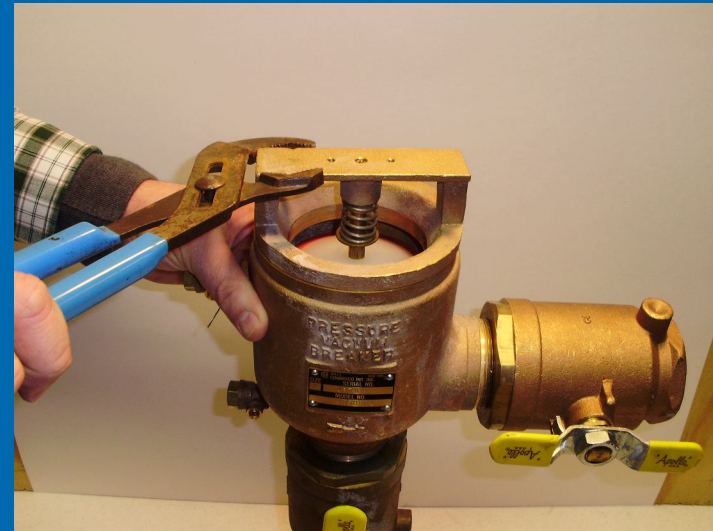
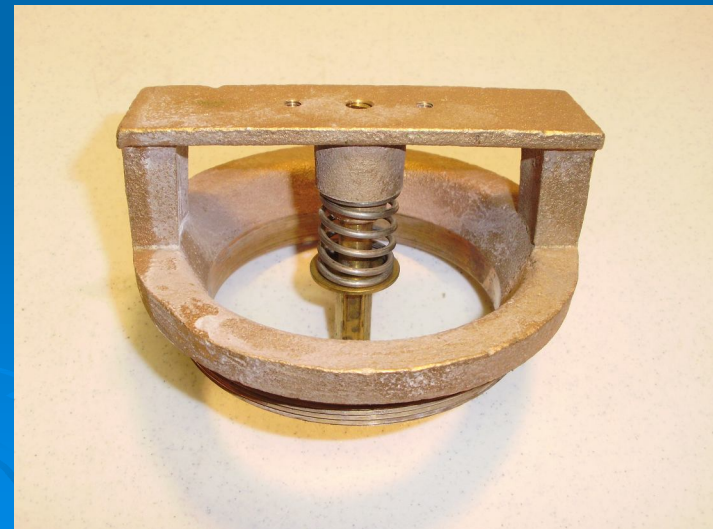
# Bonnet Removal

- The bonnet is threaded into the body and sealed by an o-ring.
- Unscrew the bonnet counter clockwise.
- There is no spring load.

Note: If float spring is damaged, the bonnet must be replaced.

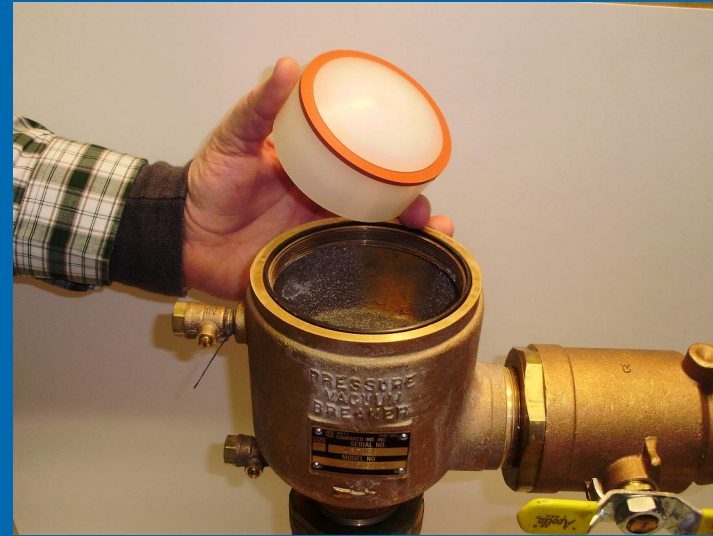
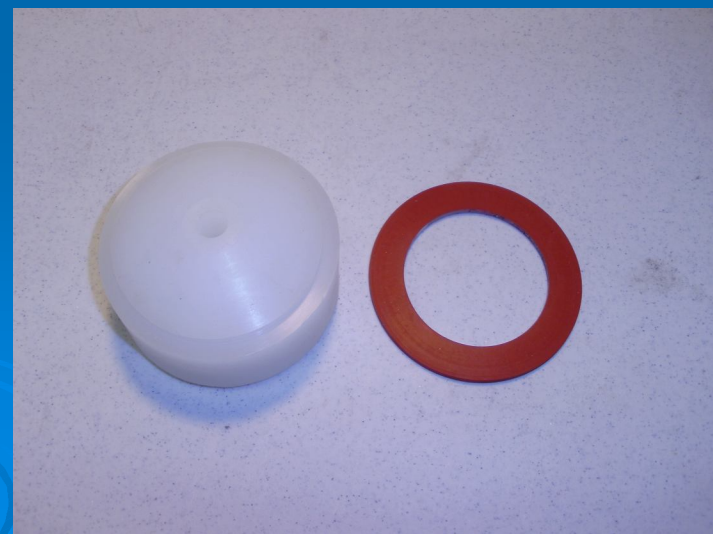
# Float Removal and Service

- The float is free once the bonnet has been removed.
- Replace the rubber seal by pulling it from the groove on the float.

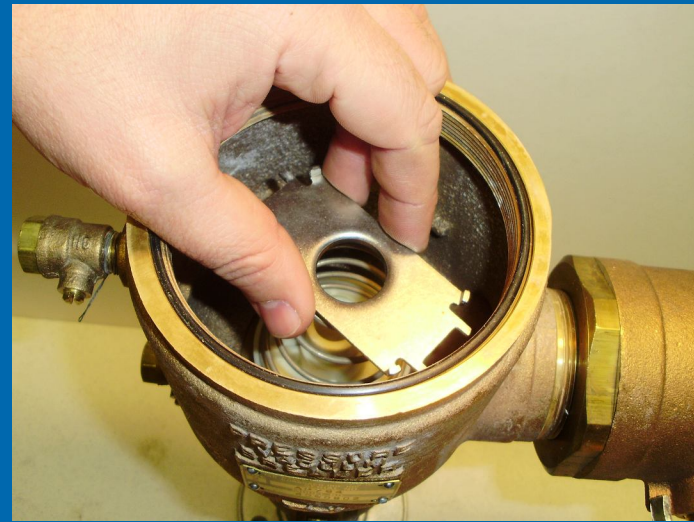
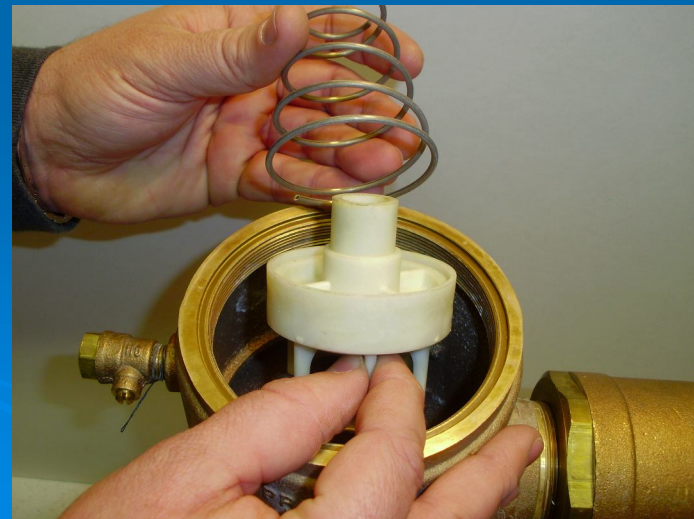
# Check Valve Removal

- Check valve is spring loaded.
- Remove spring retainer by pressing down and rotating to clear tabs on body.
- Remove spring and poppet.

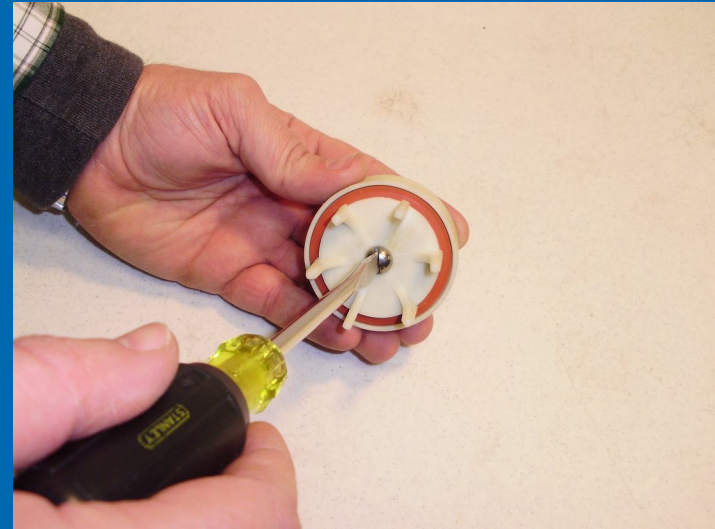
# Check Disc Replacement

- The check disc is free once the retaining screw and guide are removed.

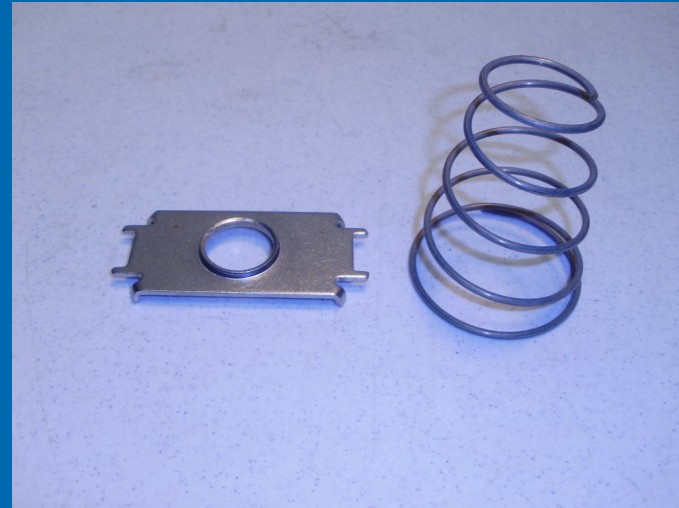
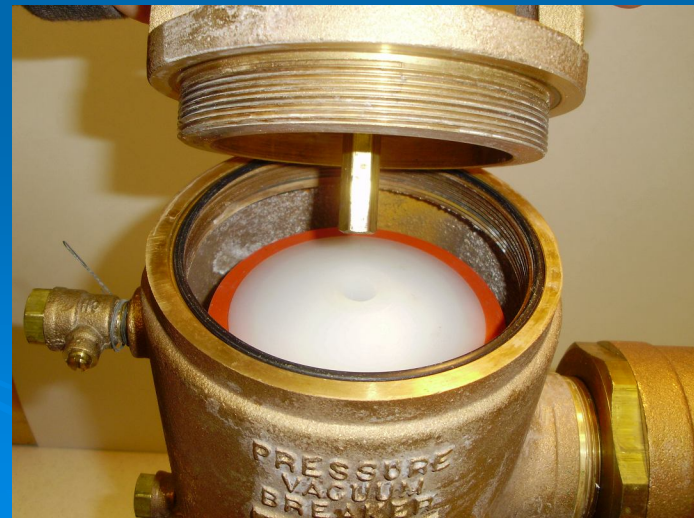
# Reassembly Notes

- Reassemble in reverse order.
- Place large end of check spring down in body.
- The lip on the retainer faces down toward the spring.
- Make sure bonnet guide stem is inserted into center of float.
