# PVB

3/4" - 1"

# *Modification Overview*

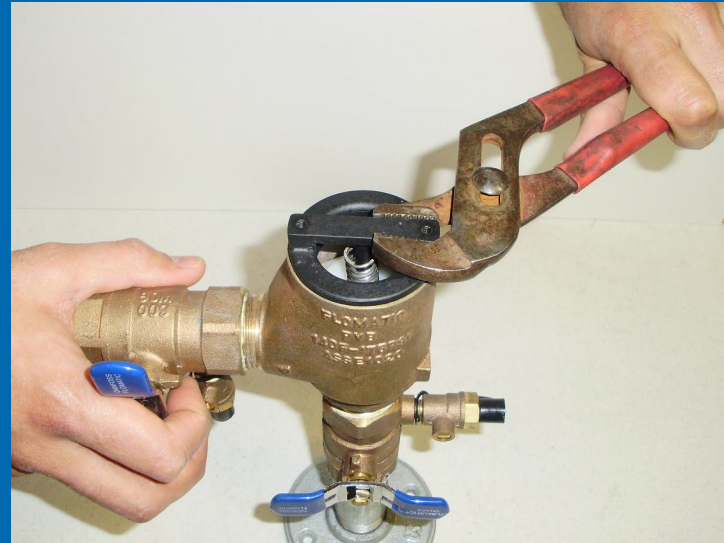
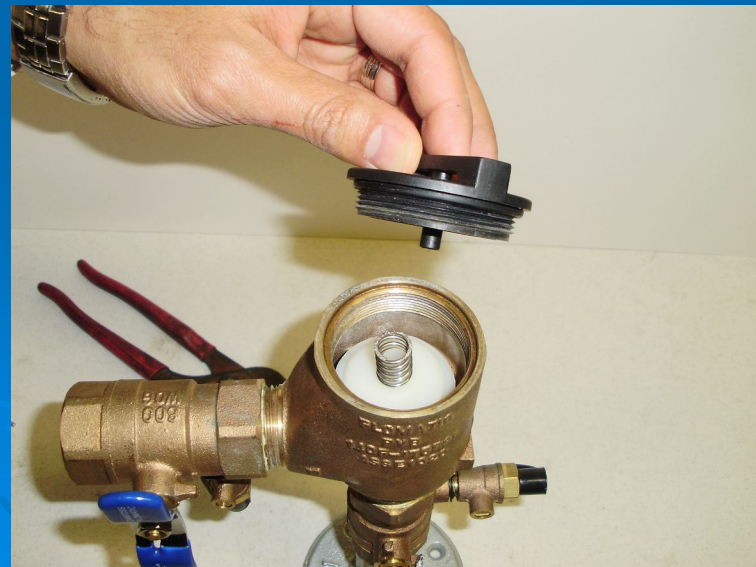
# Bonnet Removal

- The bonnet is threaded into the body and sealed by an o-ring.
- Unscrew the bonnet counter clockwise.
- There is no spring load.

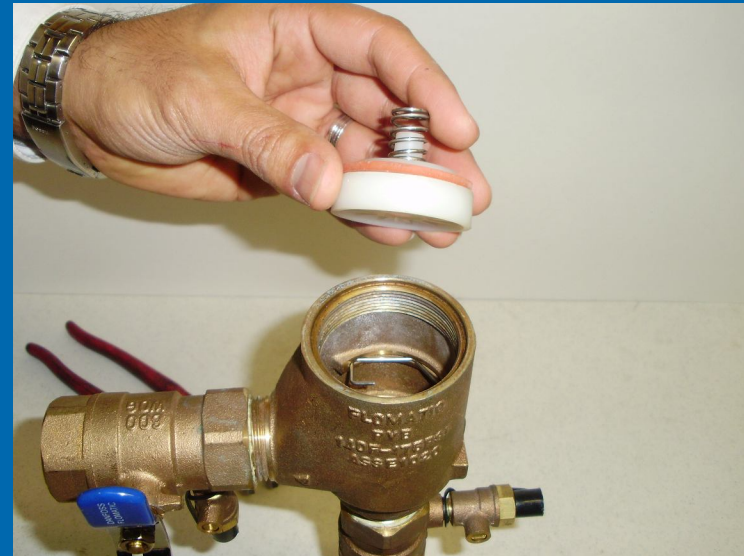
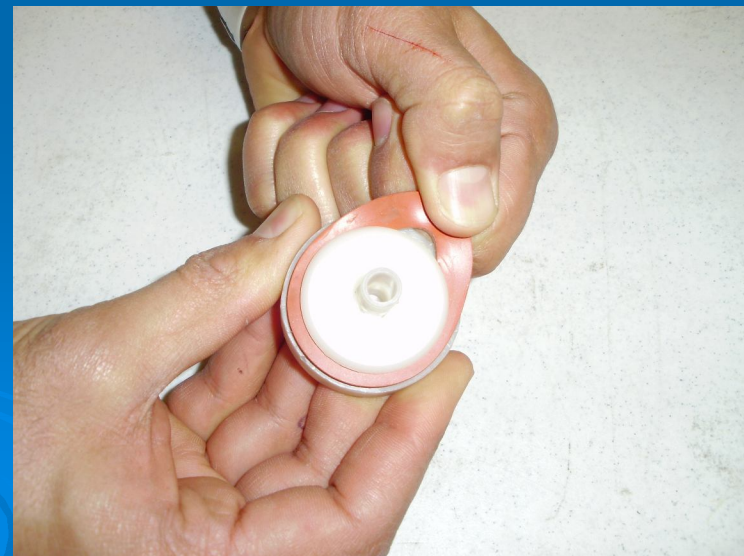
# Float Removal and Service

- The float and float spring are free once the bonnet has been removed.
- Replace the rubber seal by pulling it from the groove on the float.

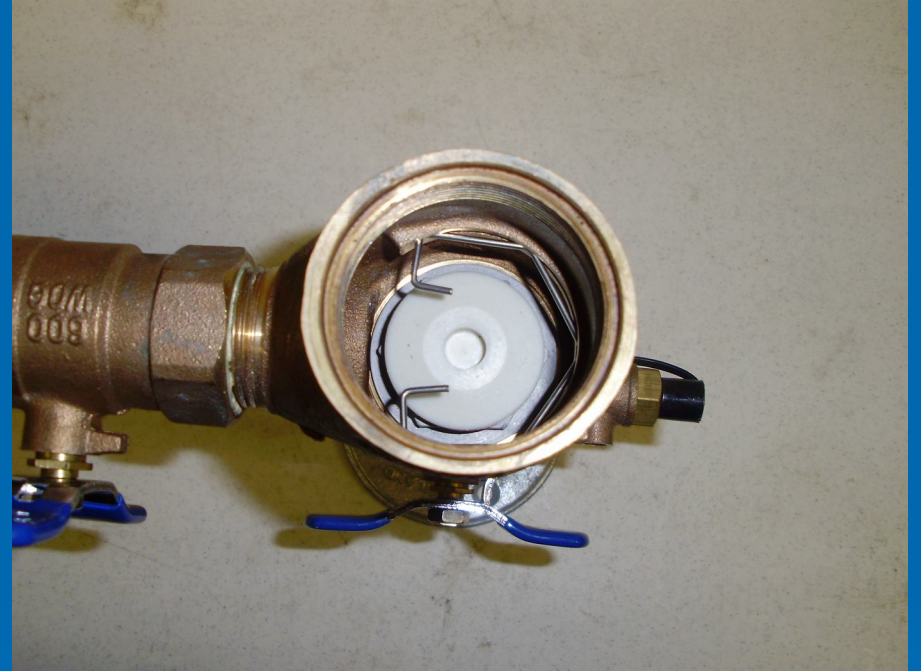
# Check Valve Removal

- The spring clip must be removed on versions made after July 2005.
- Pinch the ends of the spring clip together and pull out of the body.

\*\* Note: Use pliers if necessary.

- The body of the PVB was modified in July of 2005. A spring clip was added under the float assembly for serial numbers P0001 or larger.

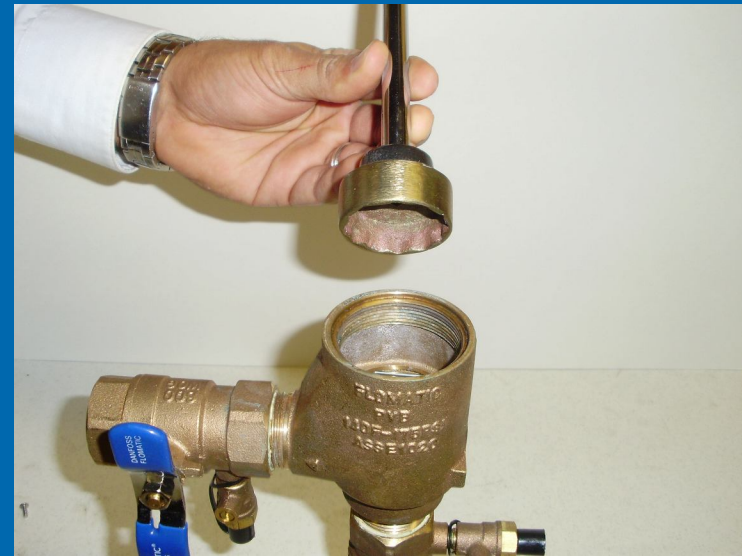
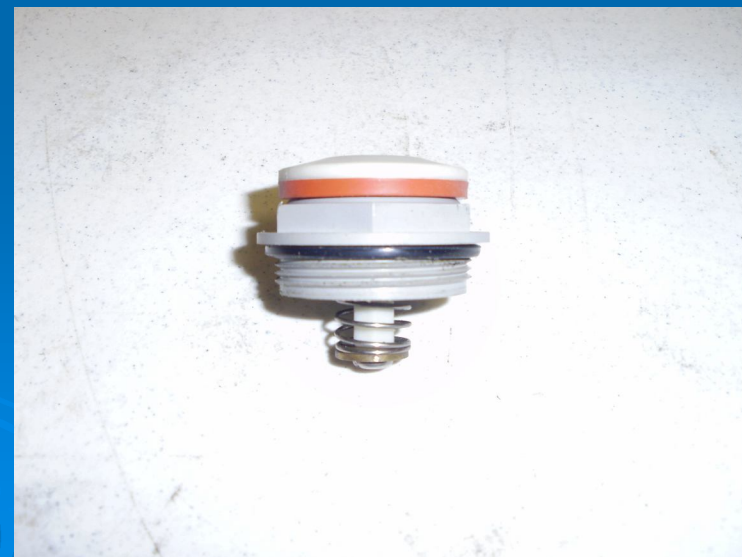
# Check Valve Removal

- The check valve is a module.
  - The check valve is threaded into the body and sealed by an o-ring.
- \* \* Note: A special tool is needed to remove the check module.

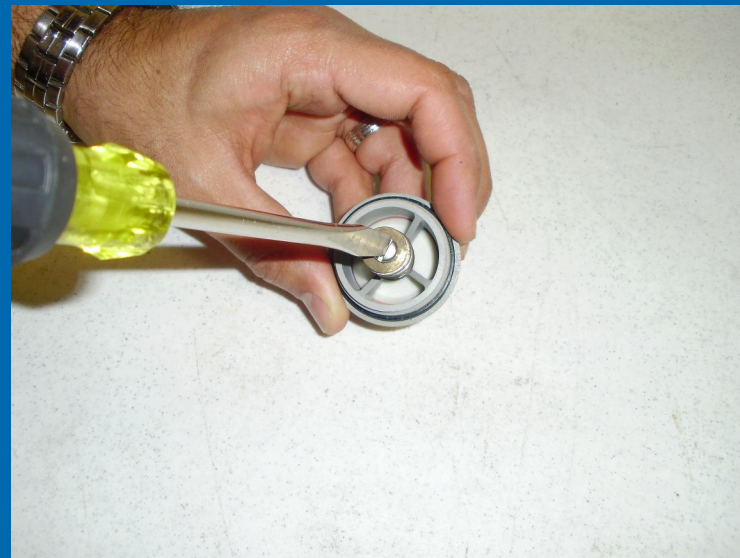
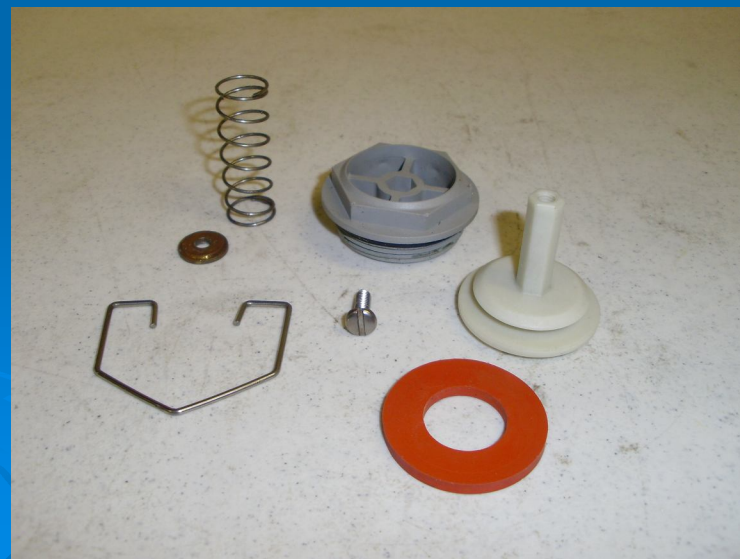
# Check Valve Disassembly

- The check module is spring loaded.
- Hold the check firmly while removing the retaining screw.

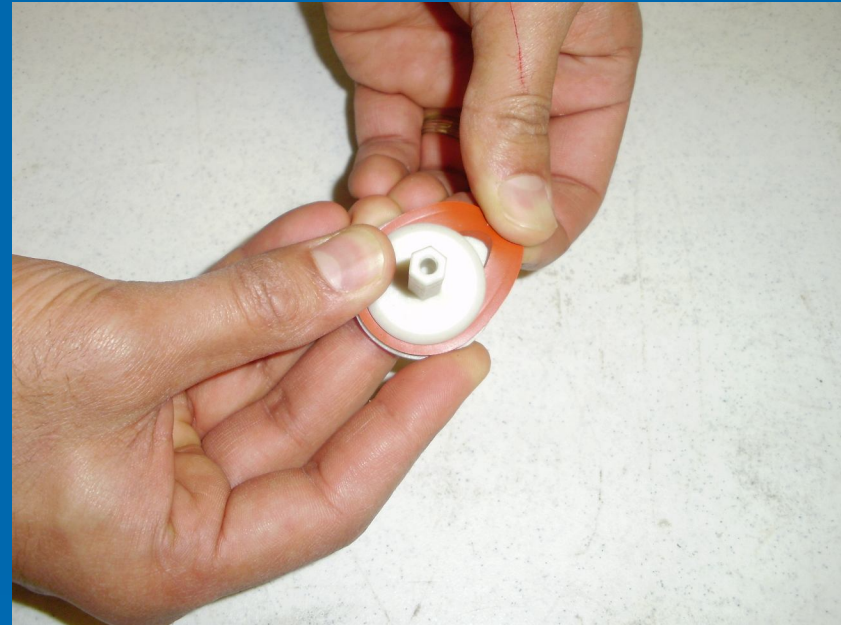
# Check Disc Replacement

- Replace the rubber disc by pulling it from the groove on the float.

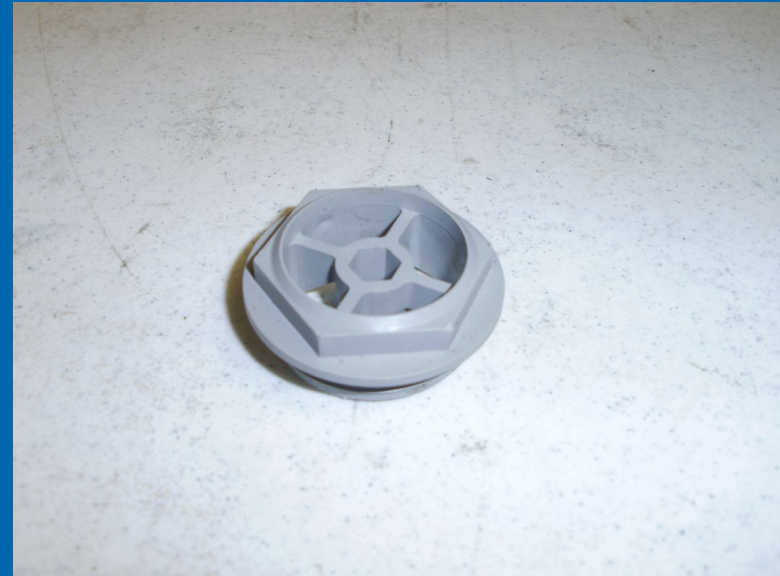
# Check Seat Replacement

- The check seat is free once the module is disassembled.
- If the seat is damaged, the check module must be replaced.

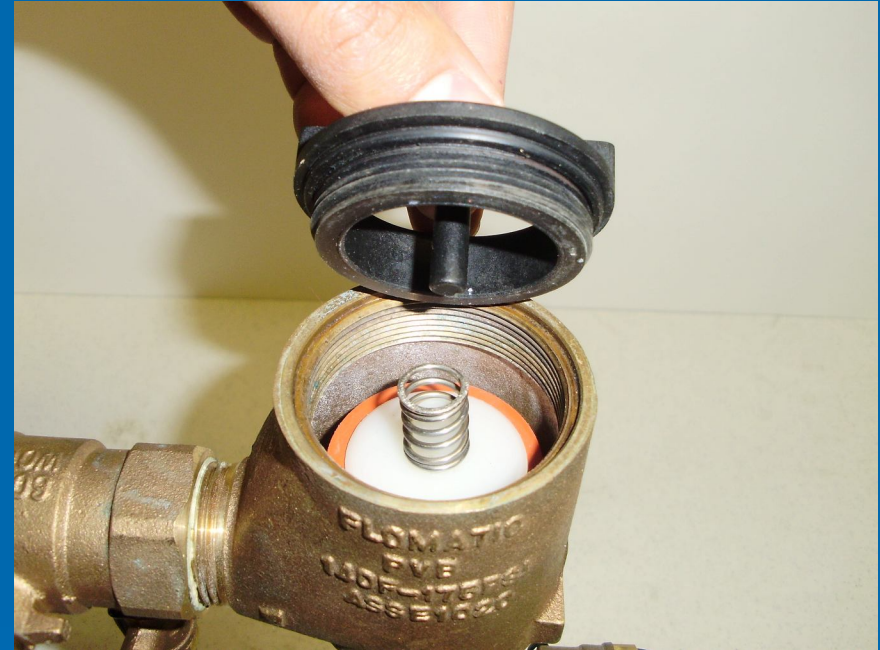
# Reassembly Notes

- Reassemble in reverse order.
- Make sure the bonnet spring is in place.
- Make sure the guide stem is inserted into the center of the float.
